DEPARTMENT OF TRANSPORTATION

Contract #: 04-0120F4Cty: SF/ALA Rte: 80 PM: 13.2/13.9File #: 99.28**WELDING INSPECTION REPORT****Resident Engineer:**Siegenthaler, Peter**Address:** 333 Burma Road**City:** Oakland, CA 94607**Report No:** WIR-020547**Date Inspected:** 11-Feb-2011**Project Name:** SAS Superstructure**OSM Arrival Time:** 700**Prime Contractor:** American Bridge/Fluor Enterprises, a JV**OSM Departure Time:** 1900**Contractor:** Zhenhua Port Machinery Company, Ltd (ZPMC)**Location:** Shanghai, China**CWI Name:** Shao Jian Yuan and Li Yan Hua**CWI Present:** Yes No**Inspected CWI report:** Yes No N/A**Rod Oven in Use:** Yes No N/A**Electrode to specification:** Yes No N/A**Weld Procedures Followed:** Yes No N/A**Qualified Welders:** Yes No N/A**Verified Joint Fit-up:** Yes No N/A**Approved Drawings:** Yes No N/A**Approved WPS:** Yes No N/A**Delayed / Cancelled:** Yes No N/A**Bridge No:** 34-0006**Component:** OBG Trial Assembly**Summary of Items Observed:**

OBG Trial Assembly: Segment 12AW

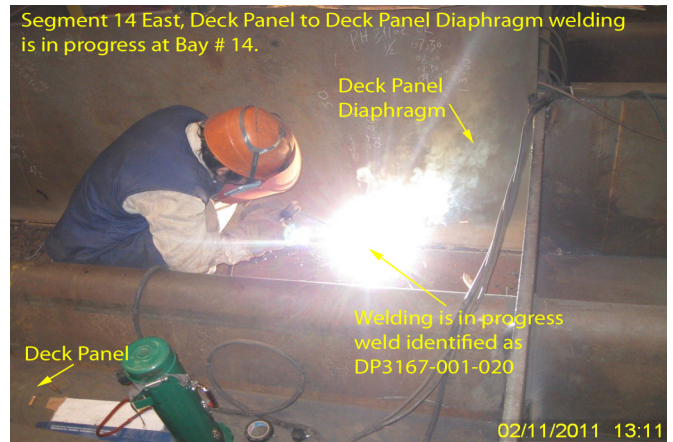
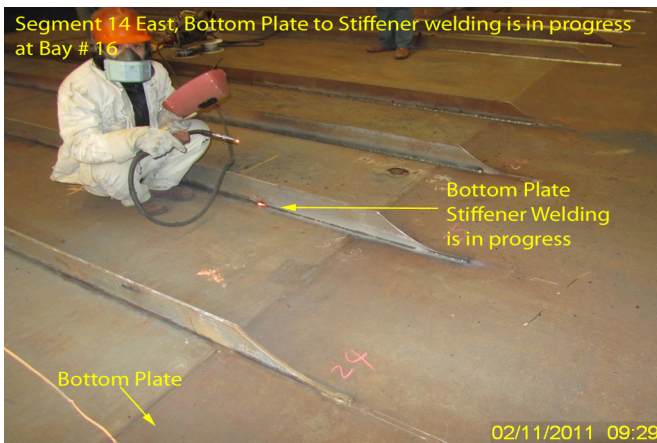
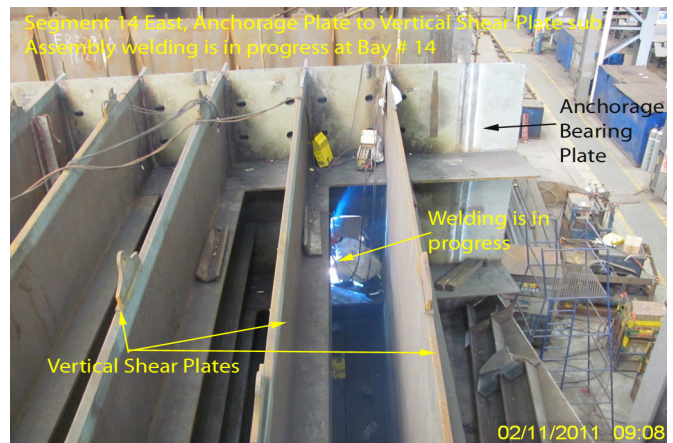
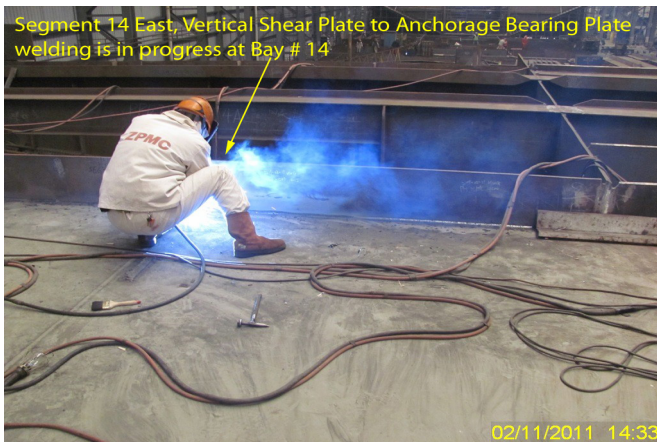
This QA Inspector observed the in-process welding by Flux Cored Arc Welding (FCAW) process on a Complete Joint Penetration (CJP) groove weld. The Weld joint was designated as BP3095-001-025. The welder identification was 067752 and observed welding in the 2G (Horizontal) position using approved Welding Procedure Specification WPS-B-T-2232-ESAB. The piece mark was identified as the weld connecting Stiffener to the Bottom Plate for Lift 14 East.

This QA Inspector observed the in-process welding by Flux Cored Arc Welding (FCAW) process on a Fillet weld. The Weld joint was designated as BP3095-001-007/008. The welder identification was 067752 and observed welding in the 2F (Horizontal) position using approved Welding Procedure Specification WPS-B-T-2132-ESAB.

This QA Inspector observed the in-process welding by Flux Cored Arc Welding (FCAW) process on a Complete Joint Penetration (CJP) groove weld. The Weld joint was designated as DP3160-001-003. The welder identification was 066439 and observed welding in the 2G (Horizontal) position using approved Welding Procedure Specification WPS-B-T-2232-ESAB. The piece mark was identified as weld connecting Deck Panel to the Longitudinal Diaphragm.

This QA Inspector observed the in-process welding by Flux Cored Arc Welding (FCAW) process on a Fillet weld. The Weld joint was designated as DP3171-001-408/409. The welder identification was 048433 and observed welding in the 3F (Vertical) position using approved Welding Procedure Specification WPS-B-T-2133-ESAB. The piece mark was identified as weld connecting Deck Panel to the Diaphragm.

This QA Inspector observed the in-process welding by Flux Cored Arc Welding (FCAW) process on a Complete Joint Penetration (CJP) groove weld. The Weld joint was designated as Seg3019BB-157. The welder identification was 066763 and observed welding in the 3G (Vertical) position using approved Welding Procedure Specification WPS-B-T-2233-ESAB. The piece mark was identified as the weld connecting the Vertical Shear Plate sub assembly to Anchorage Plate.

This QA Inspector observed the in-process welding by Flux Cored Arc Welding (FCAW) process on a Fillet weld. The Weld joint was designated as Seg3019L-054. The welder identification was 067520 and observed welding in the 2F (Horizontal) position using approved Welding Procedure Specification WPS-B-T-2132-ESAB. The piece mark was identified as the weld connecting the Vertical Shear Plate sub assembly to Anchorage Plate.
